EPA Region 10 Photolog -- DRAFT

Clean Air Act (CAA) Site Visit

Sumitomo Metal Mining Pogo LLC – near Delta Junction, AK

Dates: September 28-30, 2013

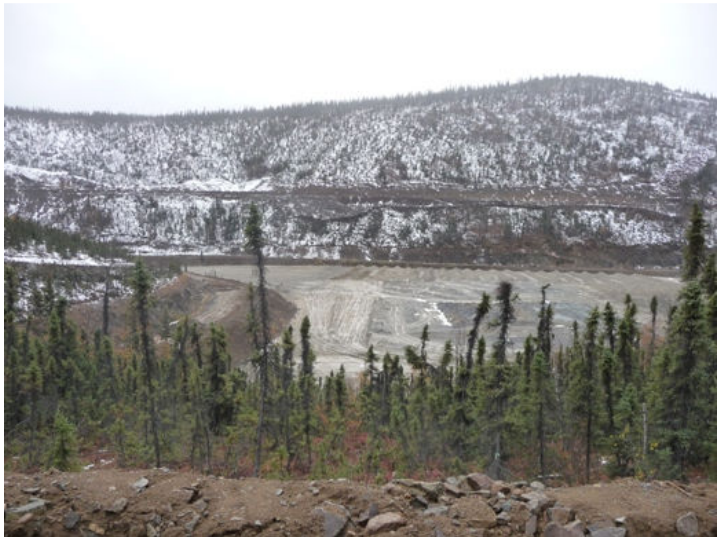
Photo P1000014.jpg

“Dry Stack” mine waste pile filling valley adjacent to Pogo Mine. View across the valley.

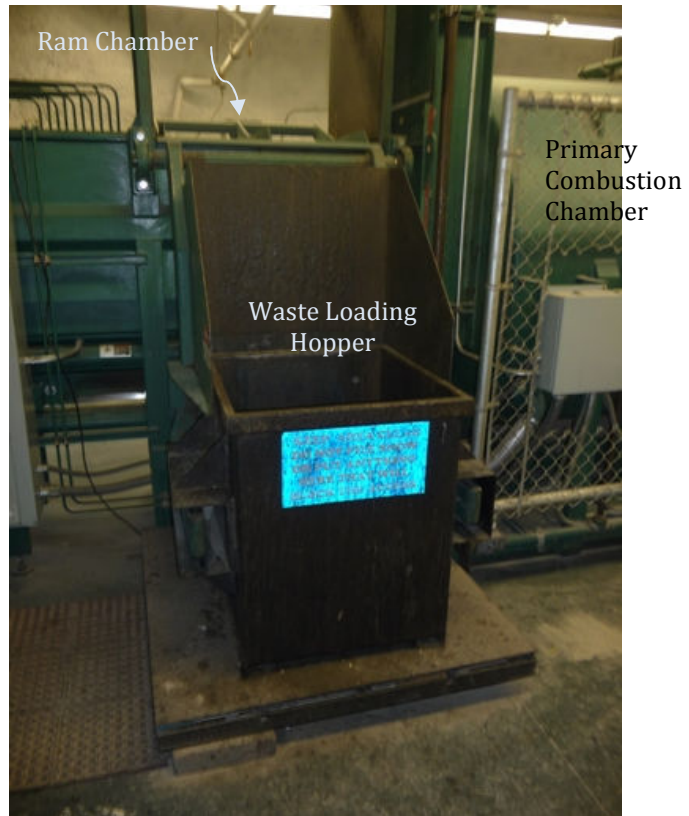
Photo P1000032.jpg

Incinerator waste loading hopper. Ram chamber is positioned directly behind the loading hopper, while the primary combustion chamber is visible to the right behind the chain link fence.

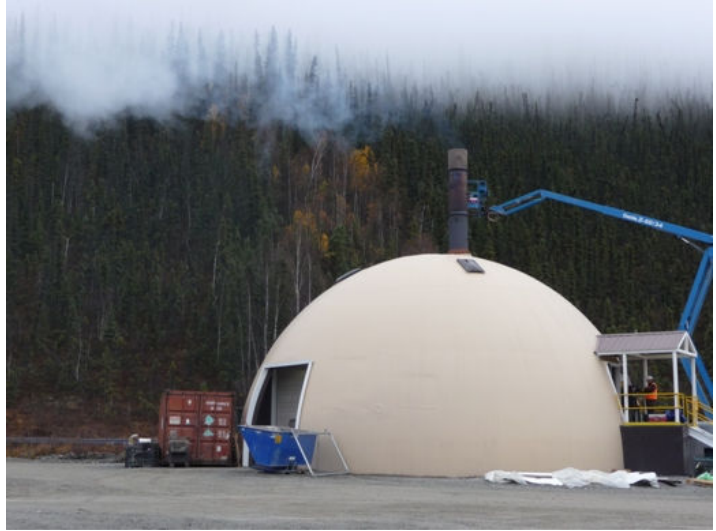
Photo P1000056.jpg

Description:
Opacity immediately following first
waste charge to warmed up
incinerator.

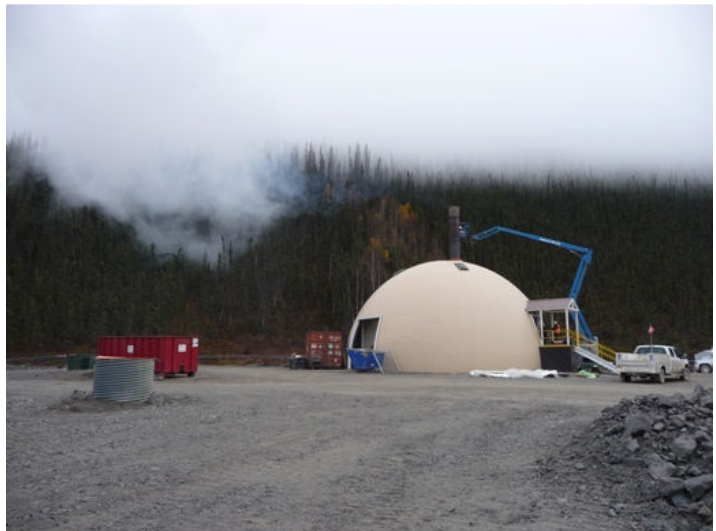
Photo P1000057.jpg

Description:
Opacity immediately following first
waste charge to warmed up
incinerator.

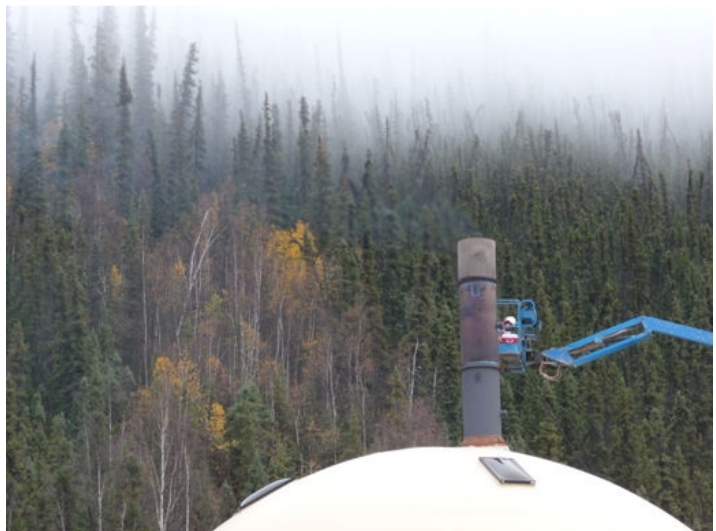
Photo P1000058.jpg

Description:
Plume opacity beginning to decrease
shortly after first waste charge.

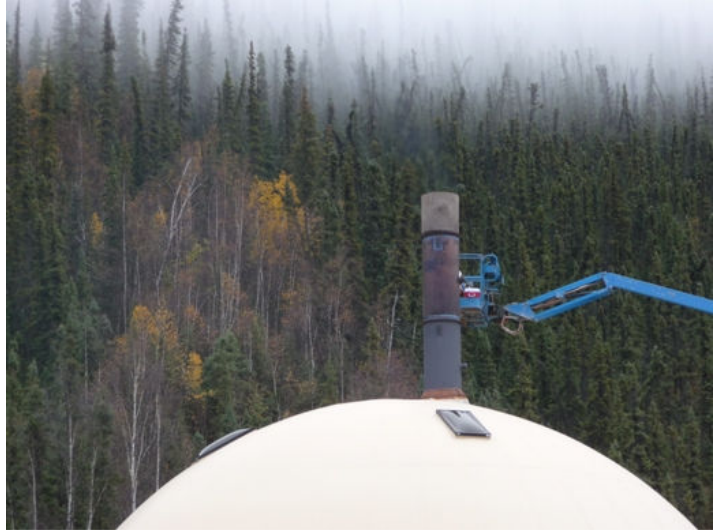
Photo P1000059.jpg

Plume opacity beginning to decrease shortly after first waste charge.

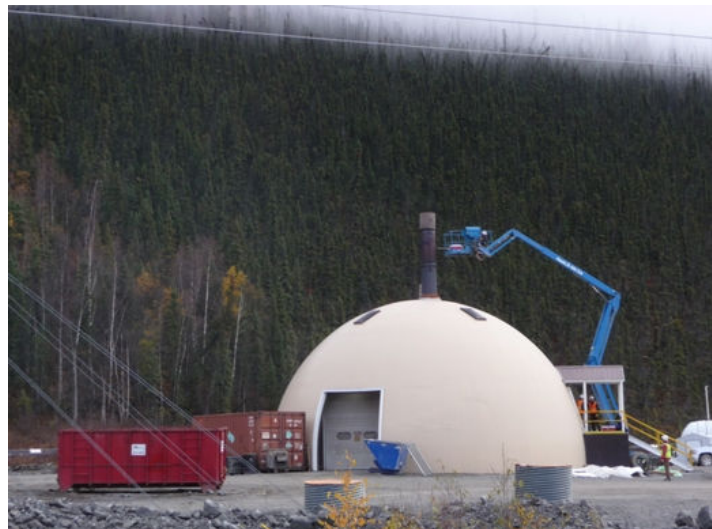
Photo P1000064.jpg

Description:
View of stack showing low opacity.

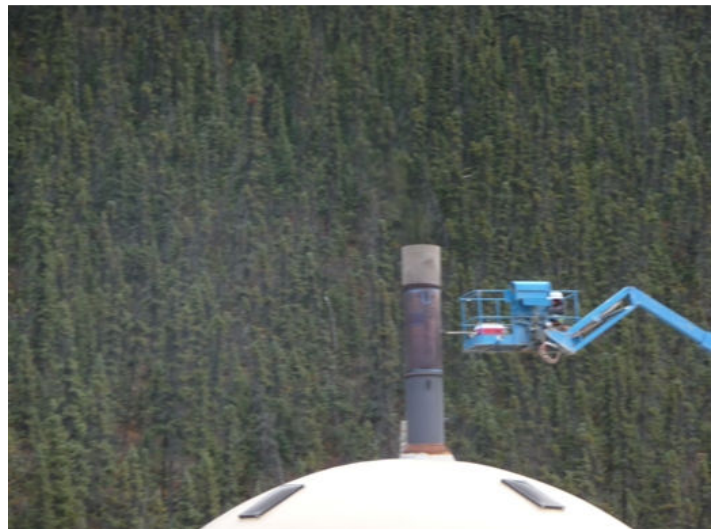
Photo P1000065.jpg

Description:
View of stack showing low opacity.

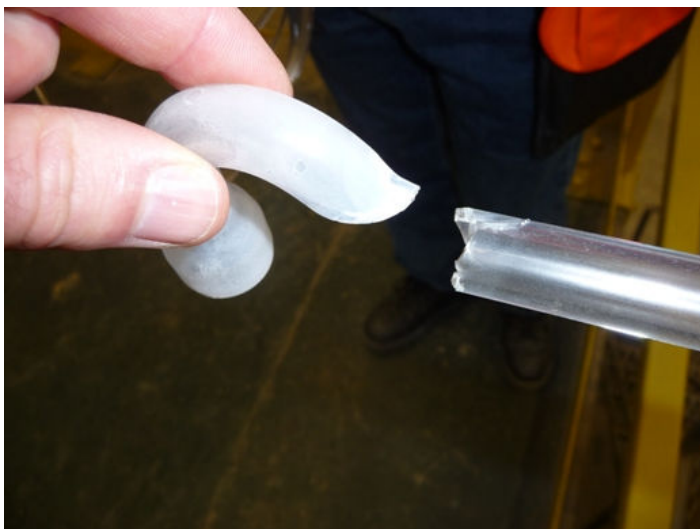
Photo P1000069.jpg

Description:
Broken quartz nozzle.

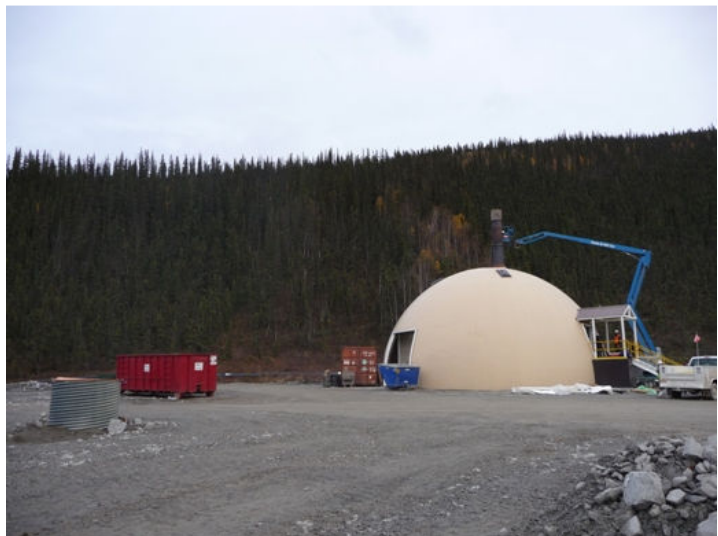
Photo P1000080.jpg

Description:
View of stack exhaust during Run
“I23-1” showing zero opacity.

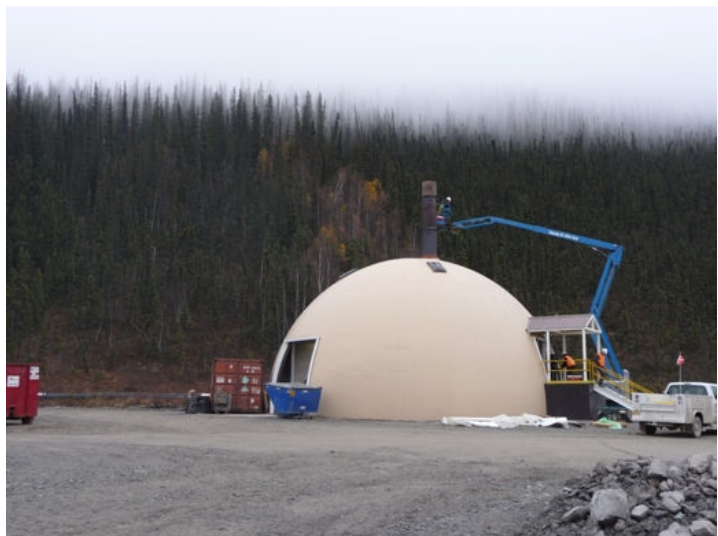
Photo P1000090.jpg

Description:
Incinerator stack following first
waste charge of the day, exhibiting
very low opacity.
